CALSPAN ON-SITE AIR BAG DEPLOYMENT INVESTIGATION

CALSPAN CASE NO. 91-4

FLEET - 1991 GEO STORM GSi

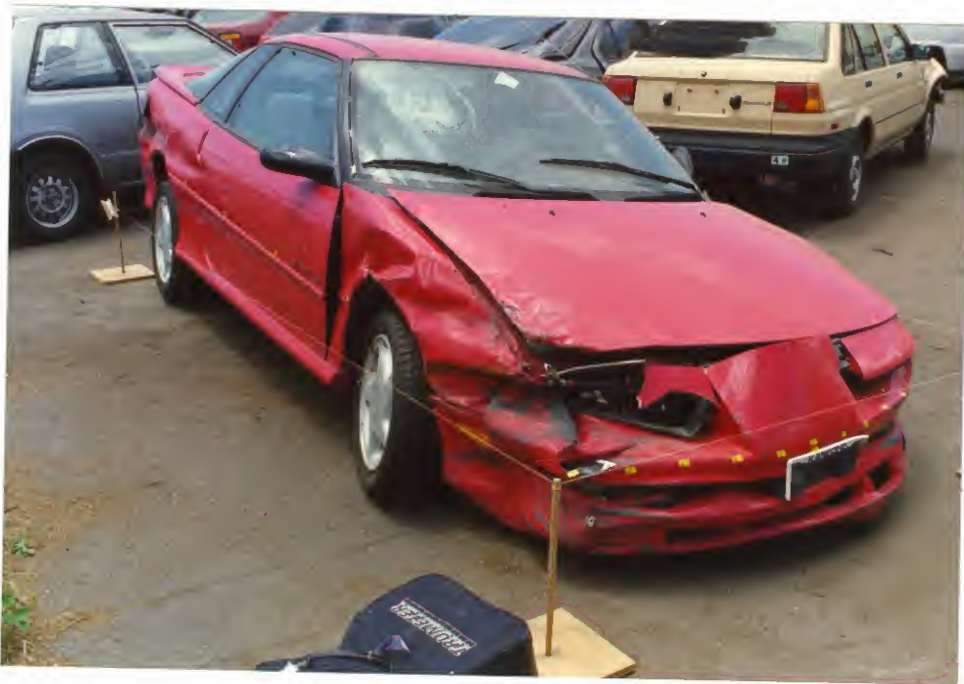
Initial Guardrail Impact Damage To The Front Right Corner Area
(Air Bag Deployment Impact Damage).

Exterior: The 1991 Geo Storm was involved in three separate impact sequences with a W-beam guardrail and a concrete median barrier. The vehicle's initial impact sequence, which deployed the driver air bag system, involved the front right area. Maximum frontal crush was 3.75" located at the right corner of the bumper. Direct contact damage began 3.875" right of center and extended 23.5" laterally to the right front bumper corner. The induced and direct contact damage (Field L) began 1.125" right of center and extended 22.25" to the right front bumper corner. (Direct contact damage was measured along the damaged profile while the Field L was measured parallel to the measurement reference line.) Crush values at the bumper reinforcement level were as follows: $C_1=0.0$, $C_2=0.0$, $C_3=0.1$ ", $C_4=0.7$ ", $C_5=2.25$ ", $C_6=3.75$ ".

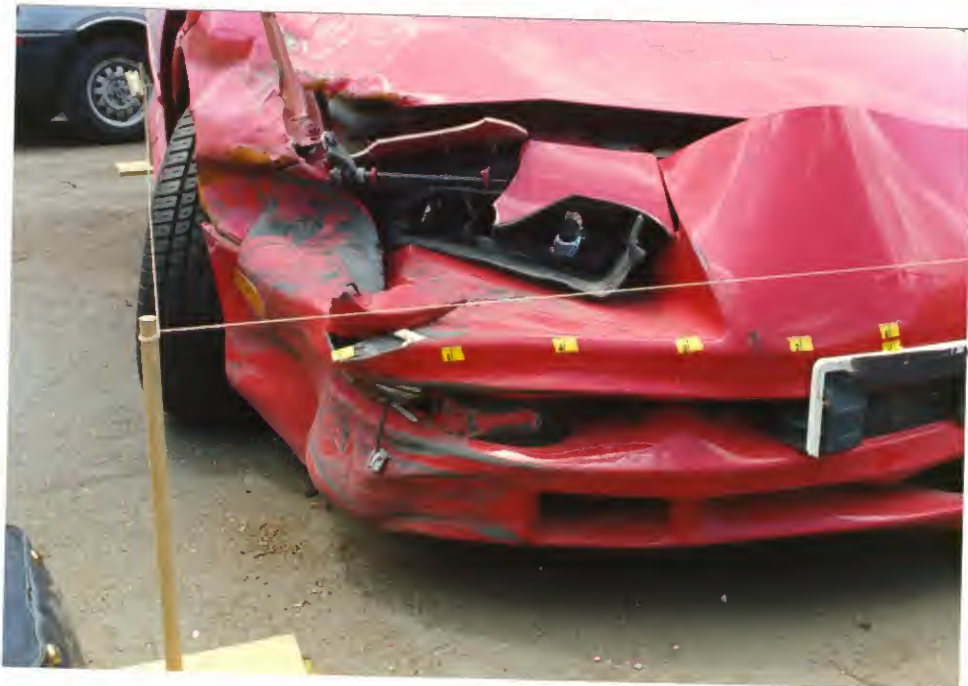
Closeup View Of The Frontal Contact Damage.

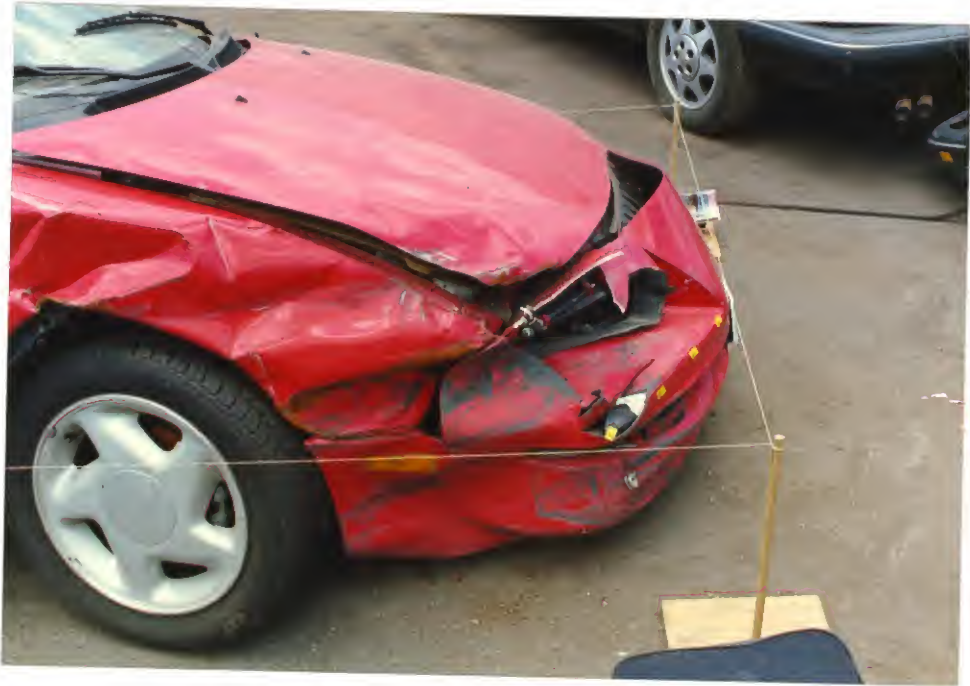
Perpendicular View Of The Right Frontal Area.

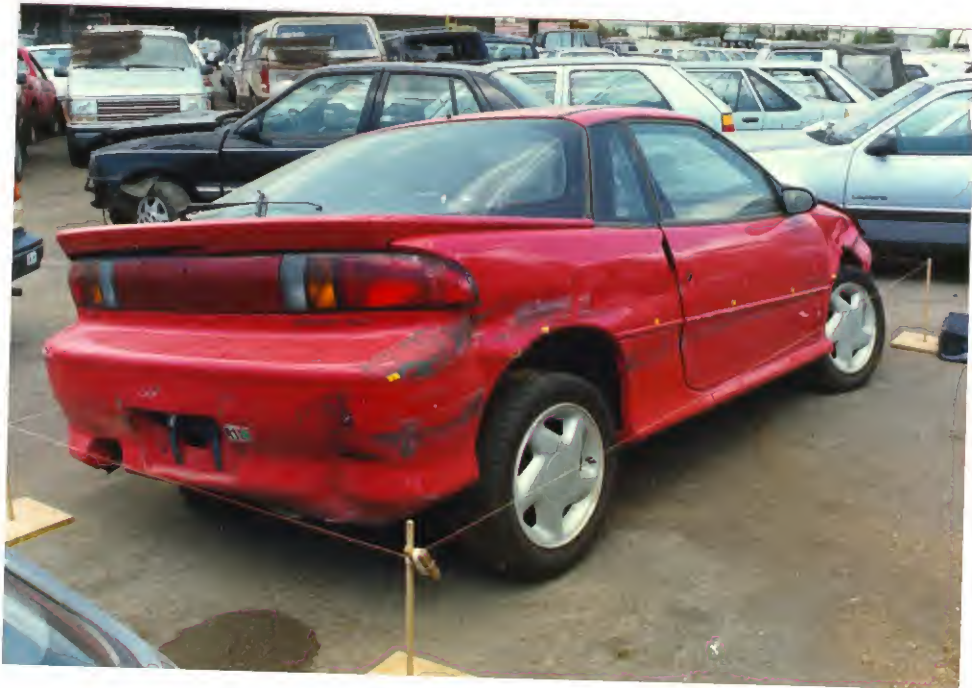
Subsequent Contact Damage Along The Right Side Of The Vehicle.

As the vehicle crushed against the guardrail, it was subsequently redirected in a counterclockwise direction. The right side of the vehicle engaged with the guardrail resulting in sideswipe type damage to the entire right side. Maximum crush to the side surface was 2.125" located at the trailing edge of the right quarter panel at the rear bumper fascia juncture.

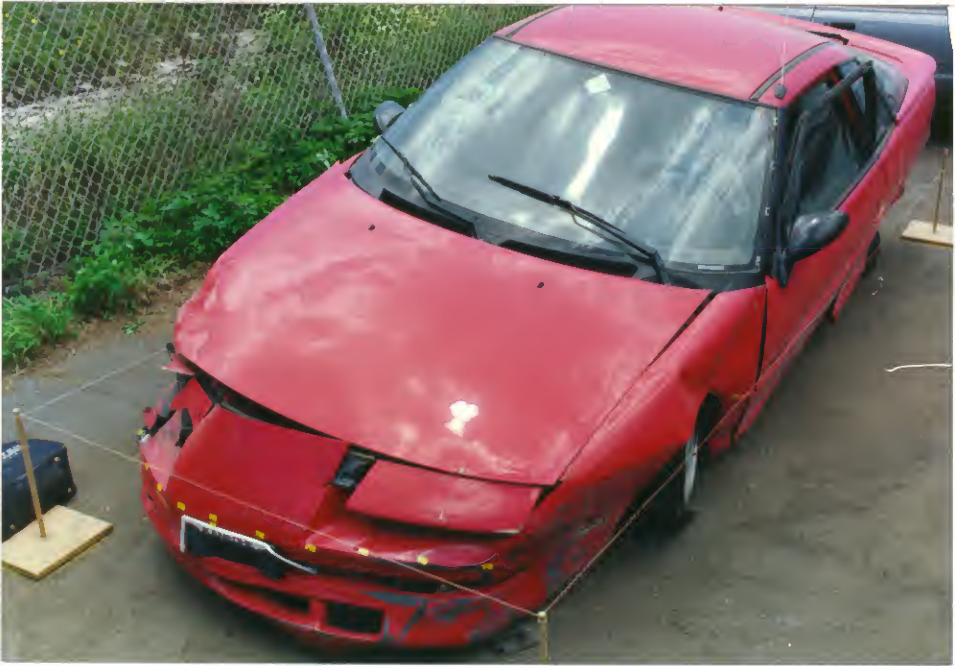
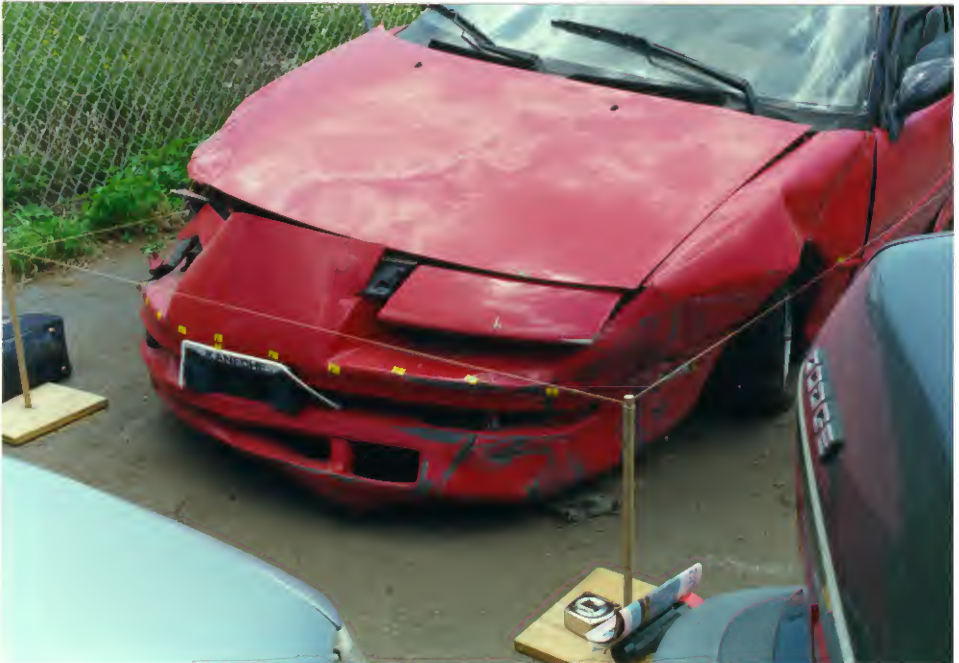
Median Barrier Impact Damage To The Left Frontal Area.

The left frontal area of the vehicle subsequently impacted the concrete median barrier resulting in 3" of bumper crush at the left corner. Direct contact damage began 1.1" right of the vehicle's center line and extended 28.1" to the left corner. Crush values at the bumper reinforcement level were as follows: $C_1=3.0"$, $C_2=1.6"$, $C_3=0.8"$, $C_4=0.2"$, $C_5=0"$, $C_6=0"$. The frontal impact sequences crushed the corners of the bumper and bowed the center outward resulting in negative crush values. The left front tire engaged with the concrete median barrier resulting in minor damage to the wheel and an airout of the left front tire. As a result of the contact, the left front axle position was displaced 4.6" rearward.

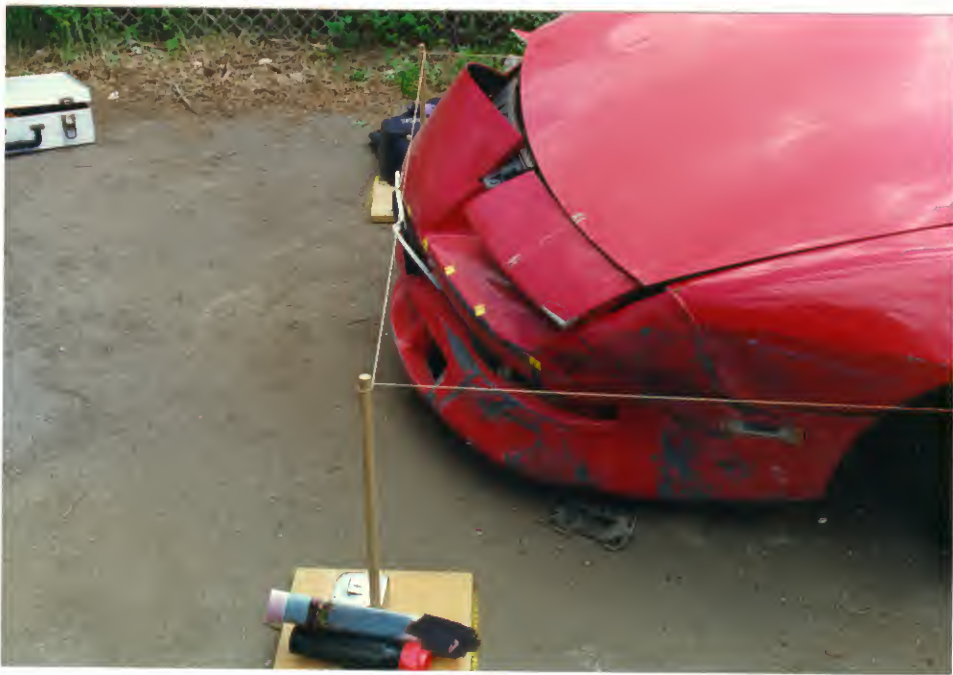
Perpendicular View Of The Left Frontal Damage.

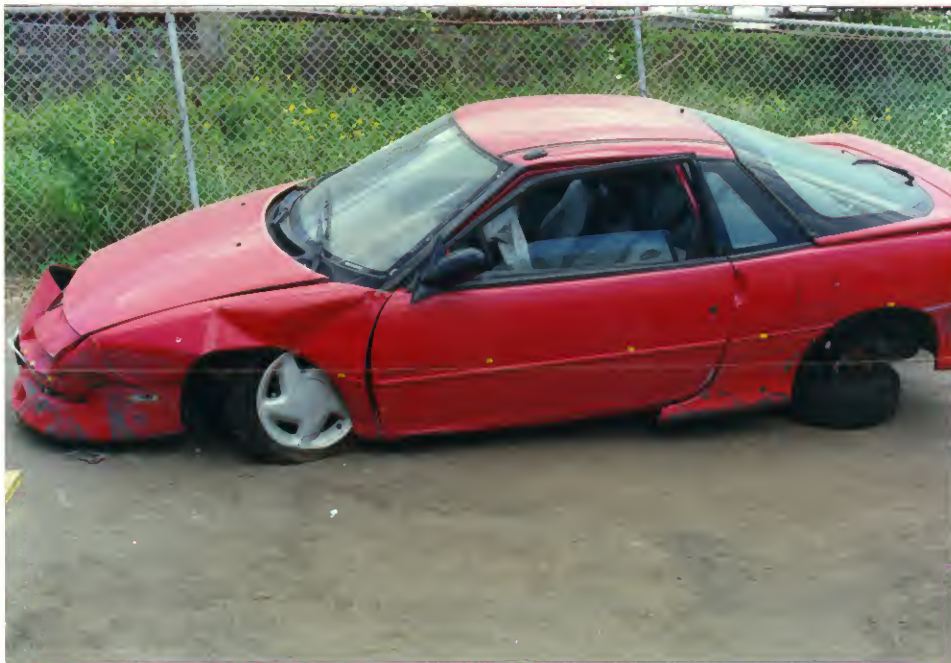
Left Side View Of The Geo Storm.

Body damage to the left side of the vehicle was minor. Maximum crush was 2.0", located at the trailing edge of the quarter panel at its juncture with the rear bumper fascia.

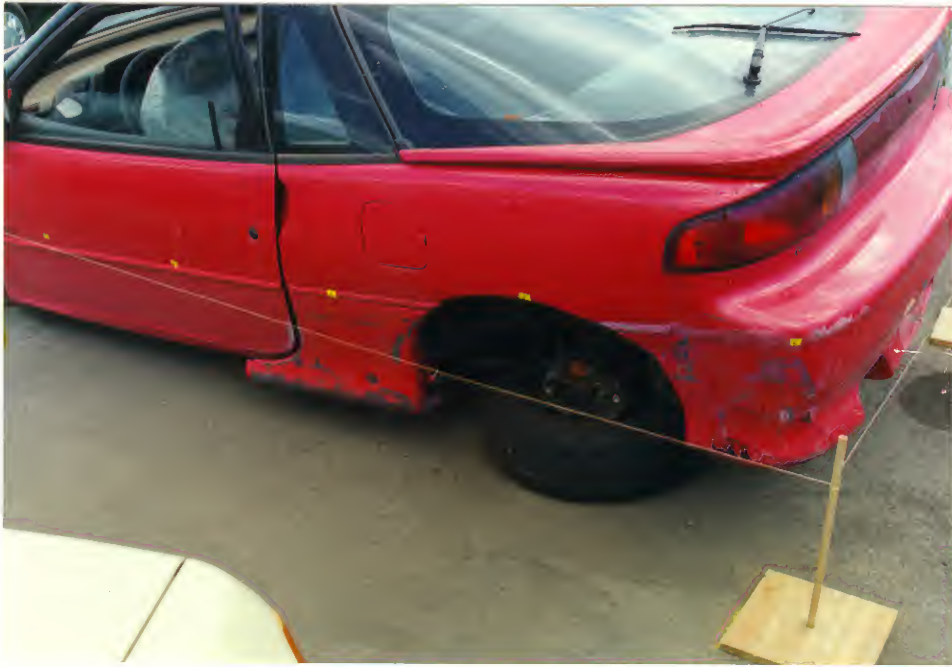
Left Rear Axle Fractured Resulting In Tire And Wheel Separation
From Contact With The Median Barrier.

The Geo Storm rotated in a CCW direction as it separated from the guardrail and crossed the westbound travel lanes. The left quarter panel area of the vehicle subsequently impacted an angled section of the concrete median barrier resulting in sideswipe type damage to the vehicle. The left rear tire contacted the barrier which sheared the axle on the inboard side of the outer rear wheel bearing. As a result, the tire/wheel and brake drum assembly separated from the vehicle. Although the tire and wheel assembly was not with the vehicle at the time of our inspection, the force load to the tire was both longitudinal and lateral. The left rear suspension components were displaced 1" rearward and the backer plate assembly for the drum brakes was canted inward at the bottom edge.

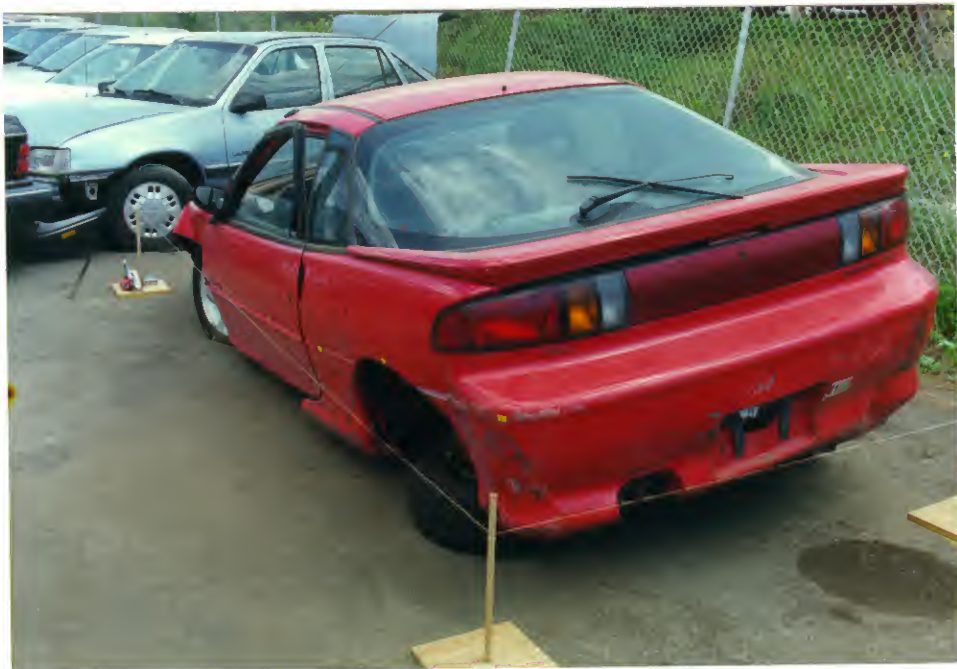
Left Rear Three-Quarter View.

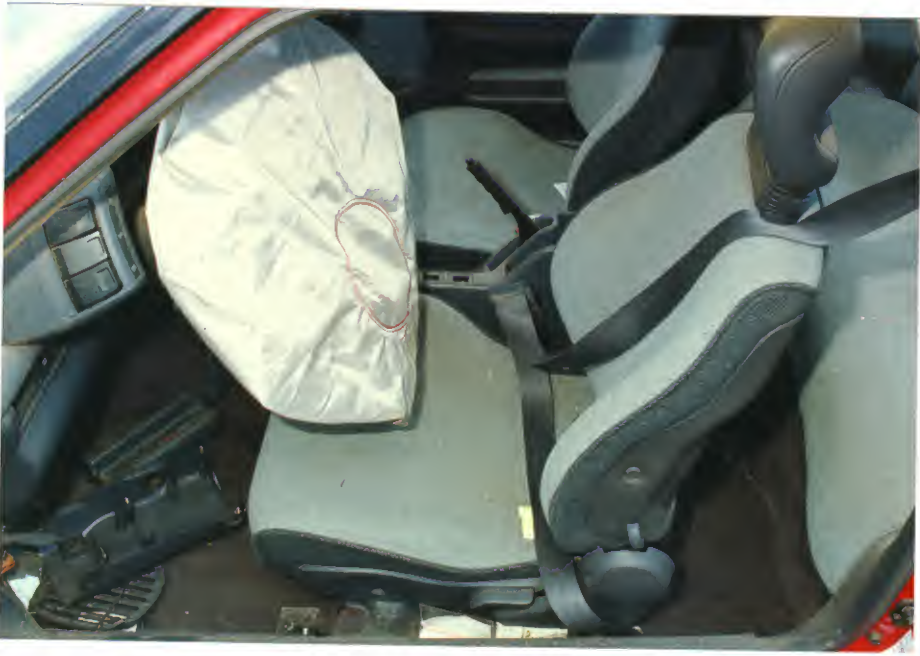
Overall Interior View Of The Driver's Seated Position,
Active Belt Webbing, And The Deployed Air Bag.

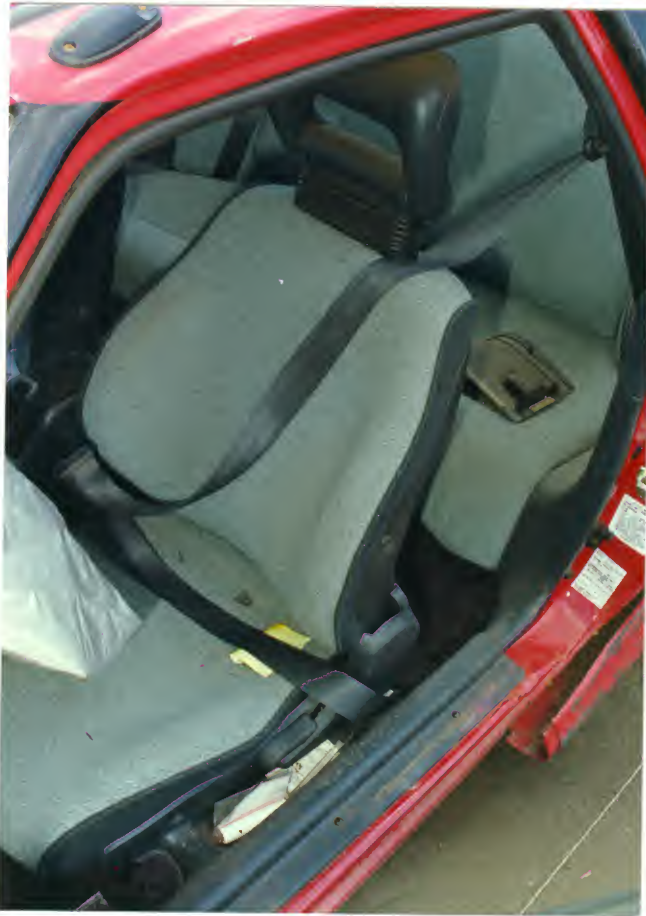
Found Adjustment Point Of The Latchplate With Respect To The
Lap And Shoulder Belt Webbing.

abrasion was located on the forward edge of the D-ring and occurred as the belt webbing loaded against the ring. There were no matching transfers on the belt webbing. The latchplate was equipped with a cinch bar which held the latchplate firmly against the belt webbing. The latchplate was found set to a point on the belt webbing that was 38.75" above the floor mounted anchor (slide bar). At this adjustment point and with the seat jammed to the middle position, the belt when buckled, was a proper fit for an occupant.

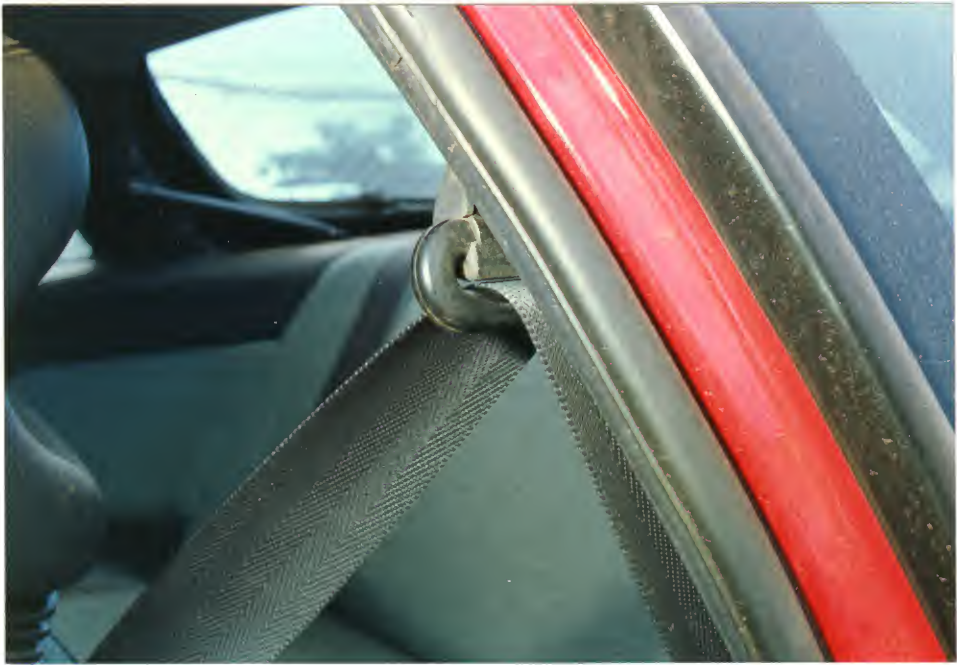
Faint Abrasion On D-Ring From Shoulder Belt Loading.

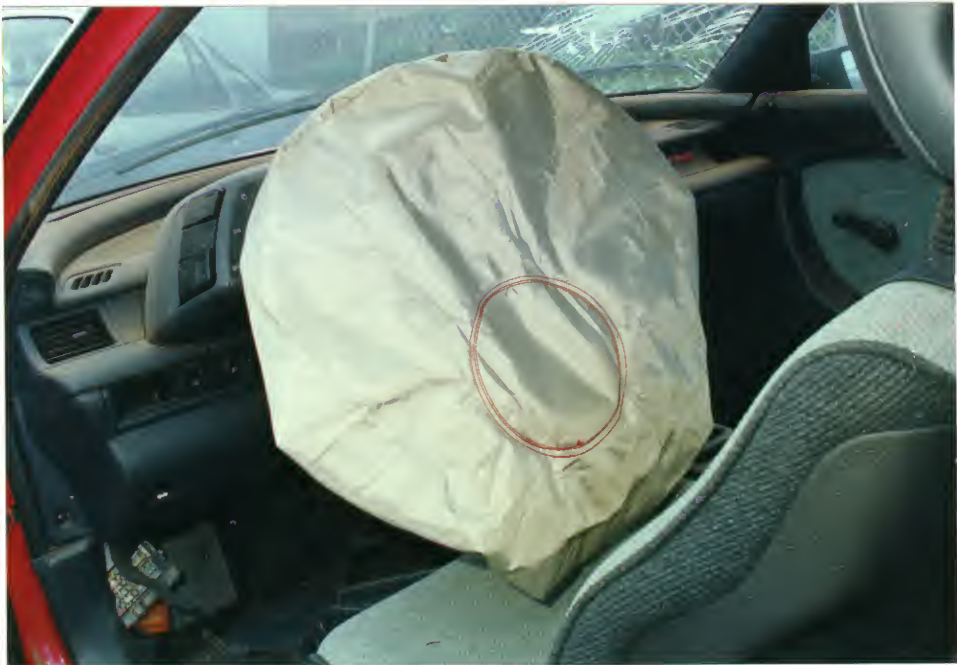
Deployed Driver Air Bag.

The air bag was not damaged during the accident sequence and did not yield evidence of occupant contact. The bag measured approximately 23.5" in diameter in its deflated, post-crash state. The air bag was vented by two ports located on the back side of the bag (away from the driver). The 1.75" diameter ports were located at the 11:30 and 1:30 o'clock positions. The bag contained 6 internal tether straps that were affixed to a 7.5" diameter reinforcement sewn to the center of the bag.

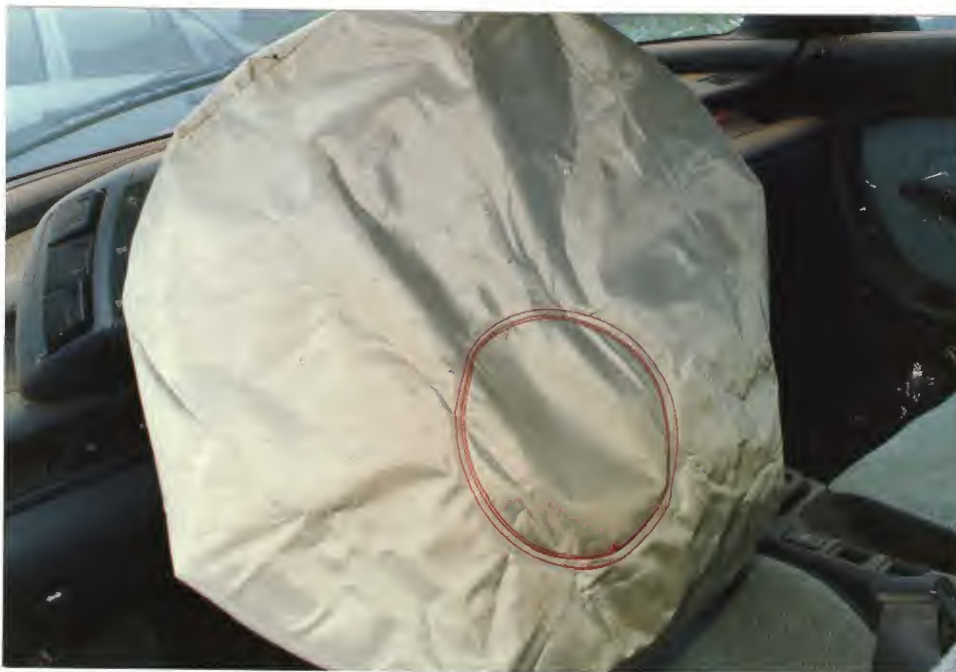
Closeup View Of The Deployed Driver Air Bag.

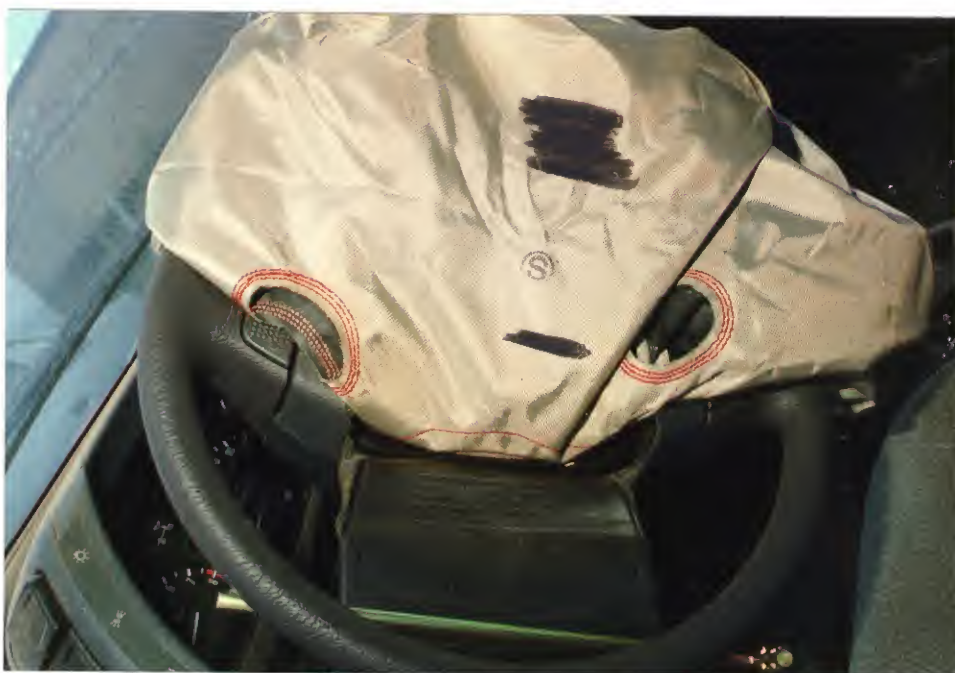
Air Bag Identification Numbers, Venting Ports, And Upper Module Flap.

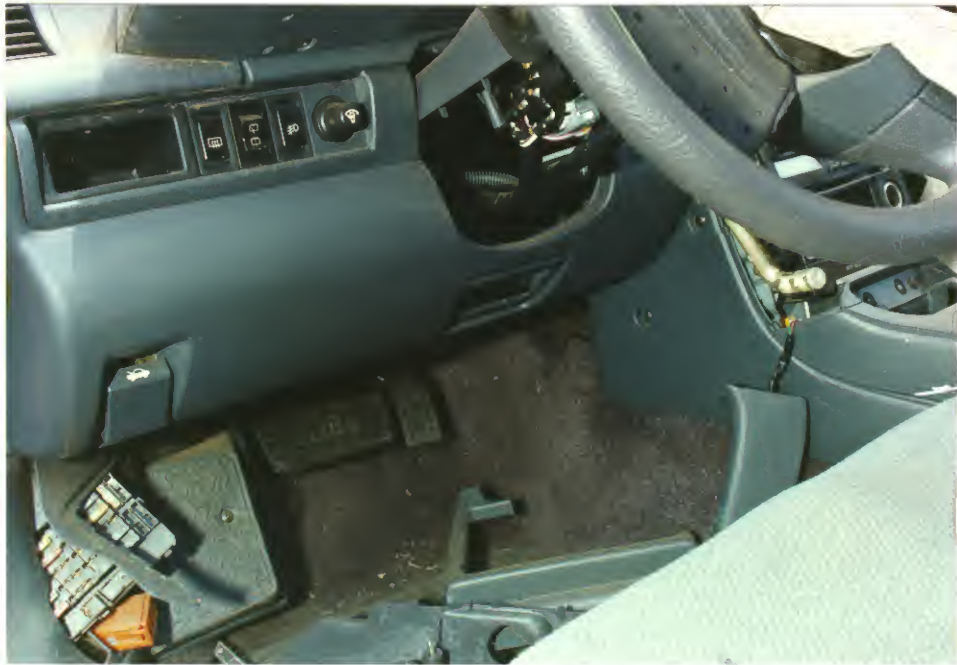
Knee Bolster (No Contact Evidence) And Intruding Toe Pan
Adjacent To A-Pillar.
